**Revitalization of architectural and ethnological heritage:
The recovery of vernacular building techniques in a
nineteenth-century winery**

Journal:	<i>International Journal of Architectural Heritage</i>
Manuscript ID:	Draft
Manuscript Type:	Original Article
Date Submitted by the Author:	n/a
Complete List of Authors:	Garcia-Esparza, Juan A.; Universitat Jaume I
Keywords:	Vernacular Building, Forensic Engineering, Historic Environments, Sustainable Management, Value Preservation

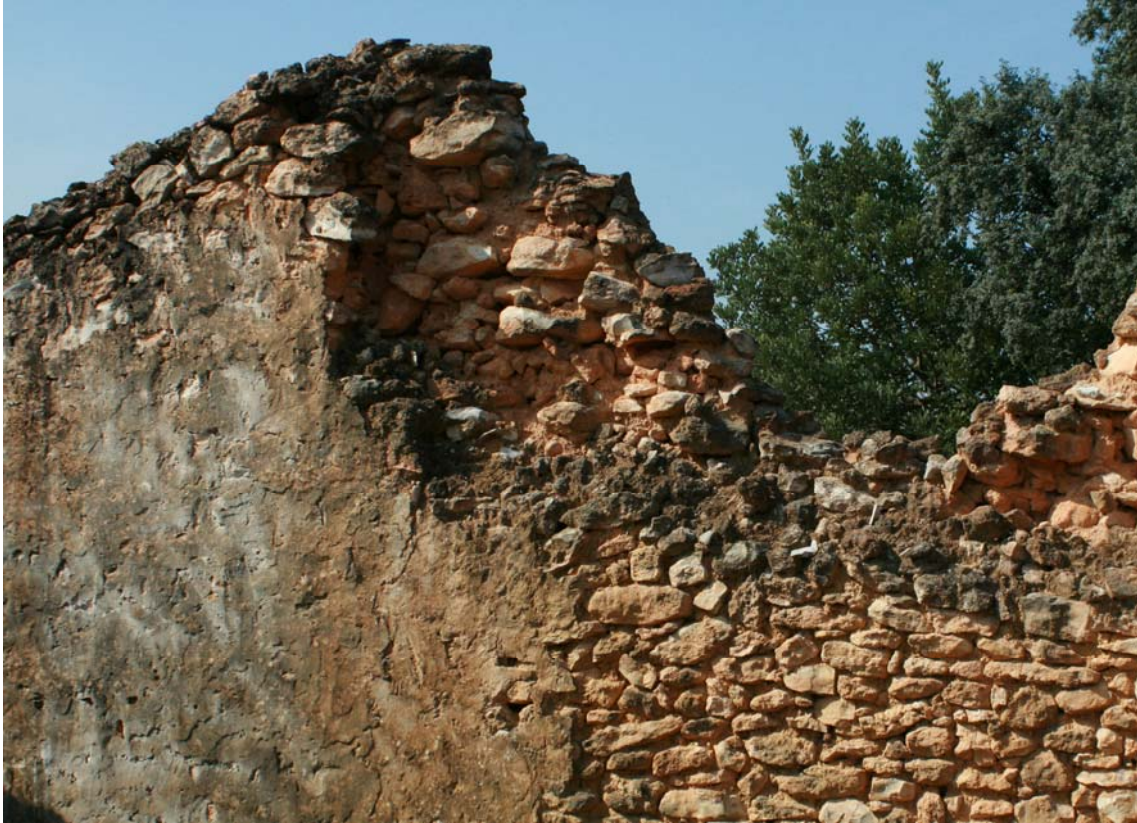
Figure 2

10
11
12 In addition, the progressively dwindling rural economy and the subsequent
13 depopulation were reflected in the abandonment of buildings connected with rural
14 dwelling patterns (buildings with stables and lofts for garnering food) and with local
15 production (windmills, wine presses, wineries, lime and plaster kilns, bread ovens,
16 etc.). This abandonment has been followed by a process of systematic replacement
17 of traditional buildings that are increasingly obsolete in their function or left derelict
18 through lack of use (Fig. 2).
19
20
21

- 1b. Interior of former winery housing a three-meter square wine vat (covering the entire right-hand side of the ground floor).
- Figure** 2. Inner face of the upper portion of the south-west wall, showing damage to both sides of the wall, the loss of mortar and stones and the loss of some parts of inner coatings.

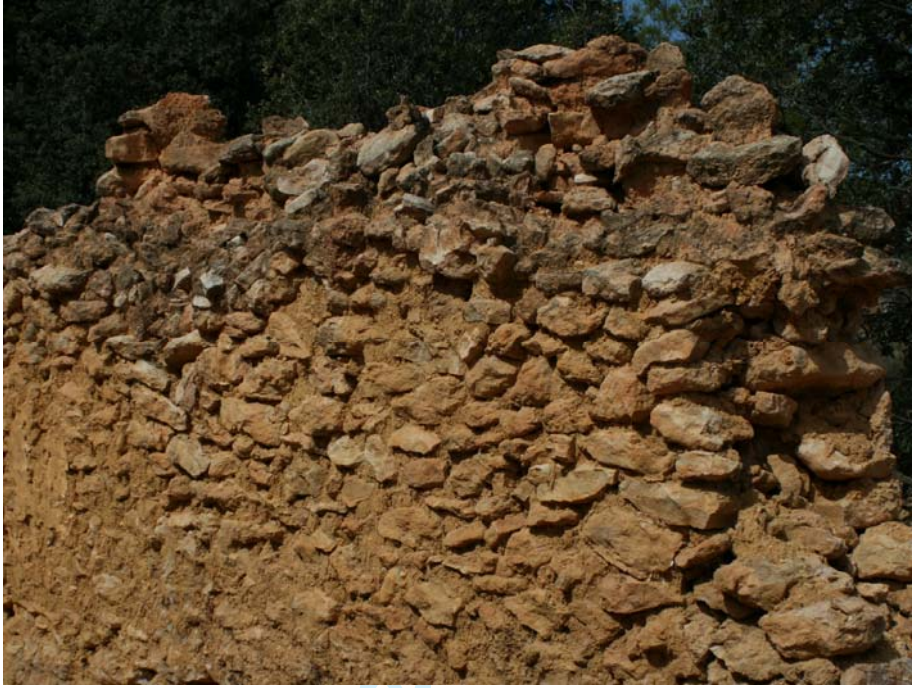
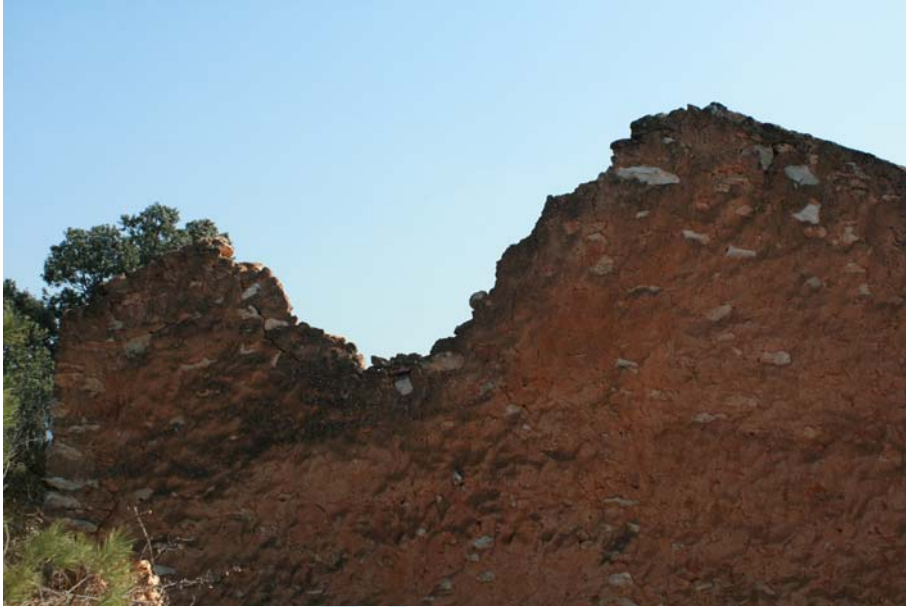
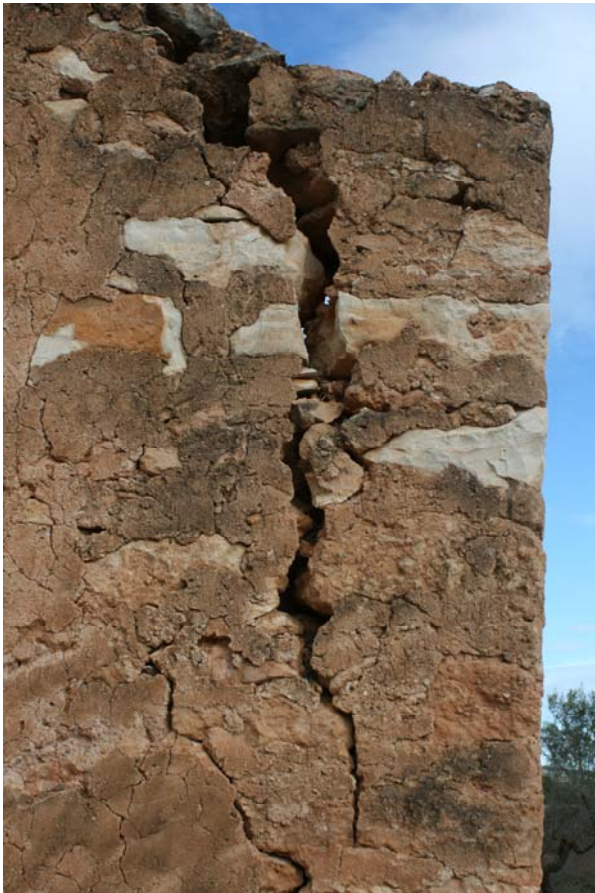
35 The characterization allowed us to find two levels of facing damage: general damage
36 located on all facings, and which corresponded to the loss of joint mortar, inner
37 disgregation forming cavities, and the loss of the coatings. And specific damage,
38 which depended on the facing, and was connected with the loss of some parts of the
39 wall as a result of the detachment of stone through impacts or slumps, or connected
40 with the loss of wall stability because of thrusts and collapse. All the damage and
41 respective repairs will be listed in sections 4.3.1 and 4.3.2 (Fig. 7a-7b-7c).
42
43
44
45
46

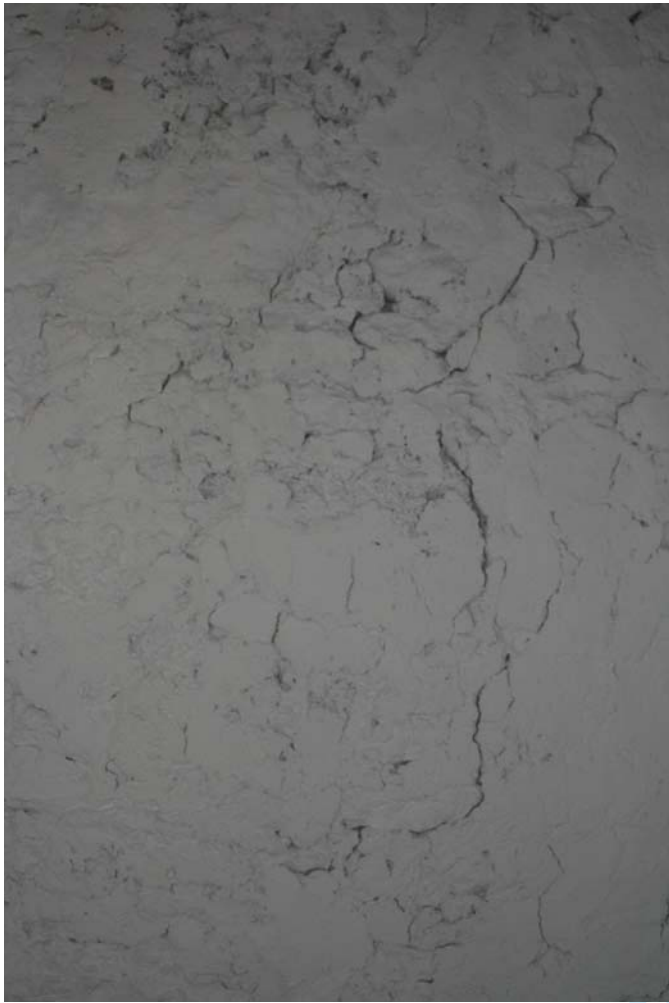
Figure 8a

- Figure** 8a. Open crack in south-east facing, given its superficial nature it is not particularly relevant. It was preserved as it was found.
- 8b. Repaired crack on inner side of joint between south-east and south-west facing. Original coatings were preserved from both facings.

The filling of cavities, generally caused by the internal degradation of the wall and the disintegration and lack of cohesion of the traditional mortar, has been carried out on all the facings of the winery using the mortar described previously with the same dosage but without medium aggregate. Once these had been filled as described, the visual appearance of the facing was hopeful compared with its prior status (Fig. 8a-8b).

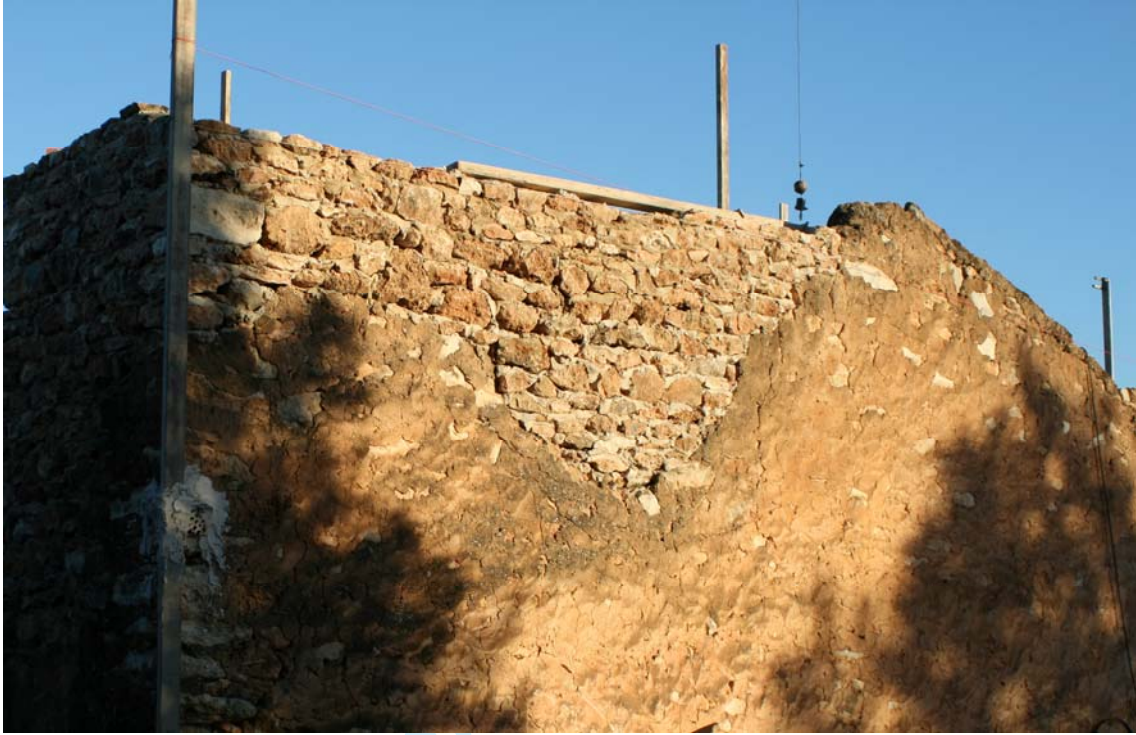
Figure 10a

Special attention was paid to reconstructing specific cracks, connected with slight collapse, provoked by occasional thrusts. The specific case of a south-west facing collapse showed a serious crack above which masonry walls were meant to be built up. After checking its stability and ensuring that the resulting mass center of the wall was within its base, we decided to preserve the collapse as a historical feature (Fig. 10a).

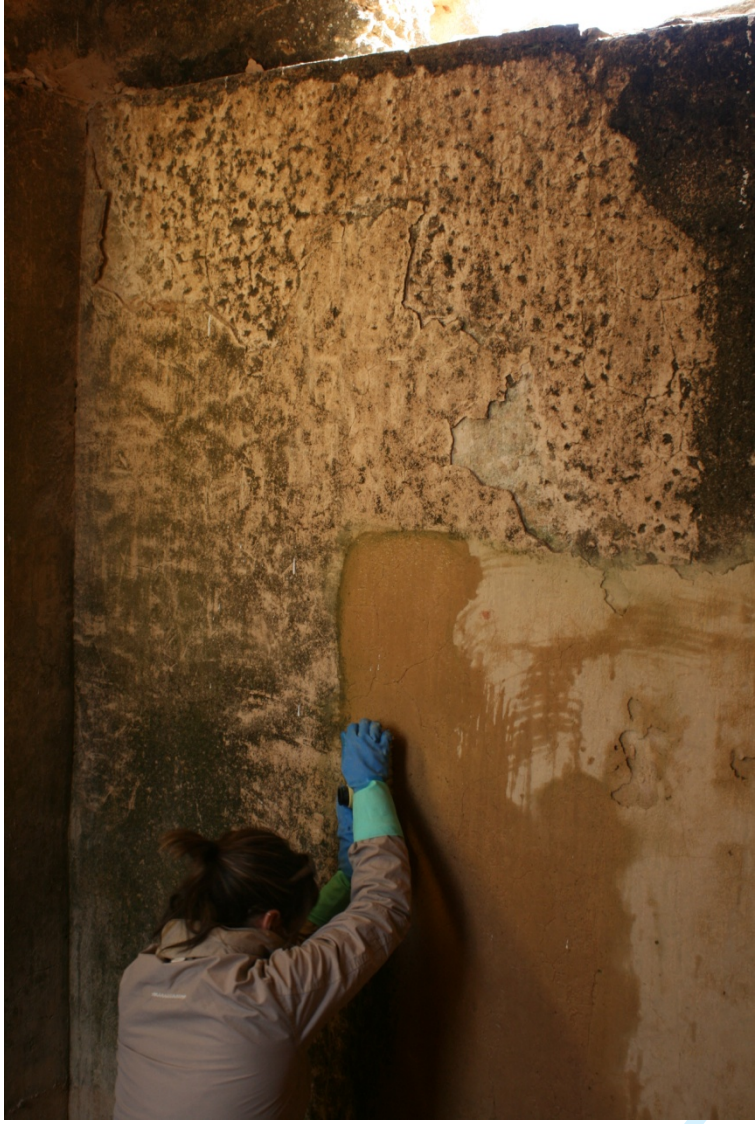
Figure 12a

Figure 12a. Coatings of the former winery, testing new consolidations with different layers of limewash varying in density and color.

7
8 The need to coat the facings externally is closely tied to the protection of stone that is
9 physically or chemically unstable from exposure to extremes of heat and cold, or the
10 biological aggressions of micro and macro vegetation. The need for interior coatings
11 on the facing is directly linked with the compacting action, a rapid and energetic
12 application of layers of mortar to compact the facing by joining its components and
13 reducing interstitial spaces (Gárate, 2002) (Fig. 12a-12b).
14
15
16
