# Bricked vaults of the 18th century Valencian hall churches: graphical representation, constructive and pathological analysis

Beatriz Sáez Riquelme<sup>1</sup>

<sup>1</sup> *Departamento Ennginyeria de Sistemes Industrials i Dissey, Universitat Jaume I*

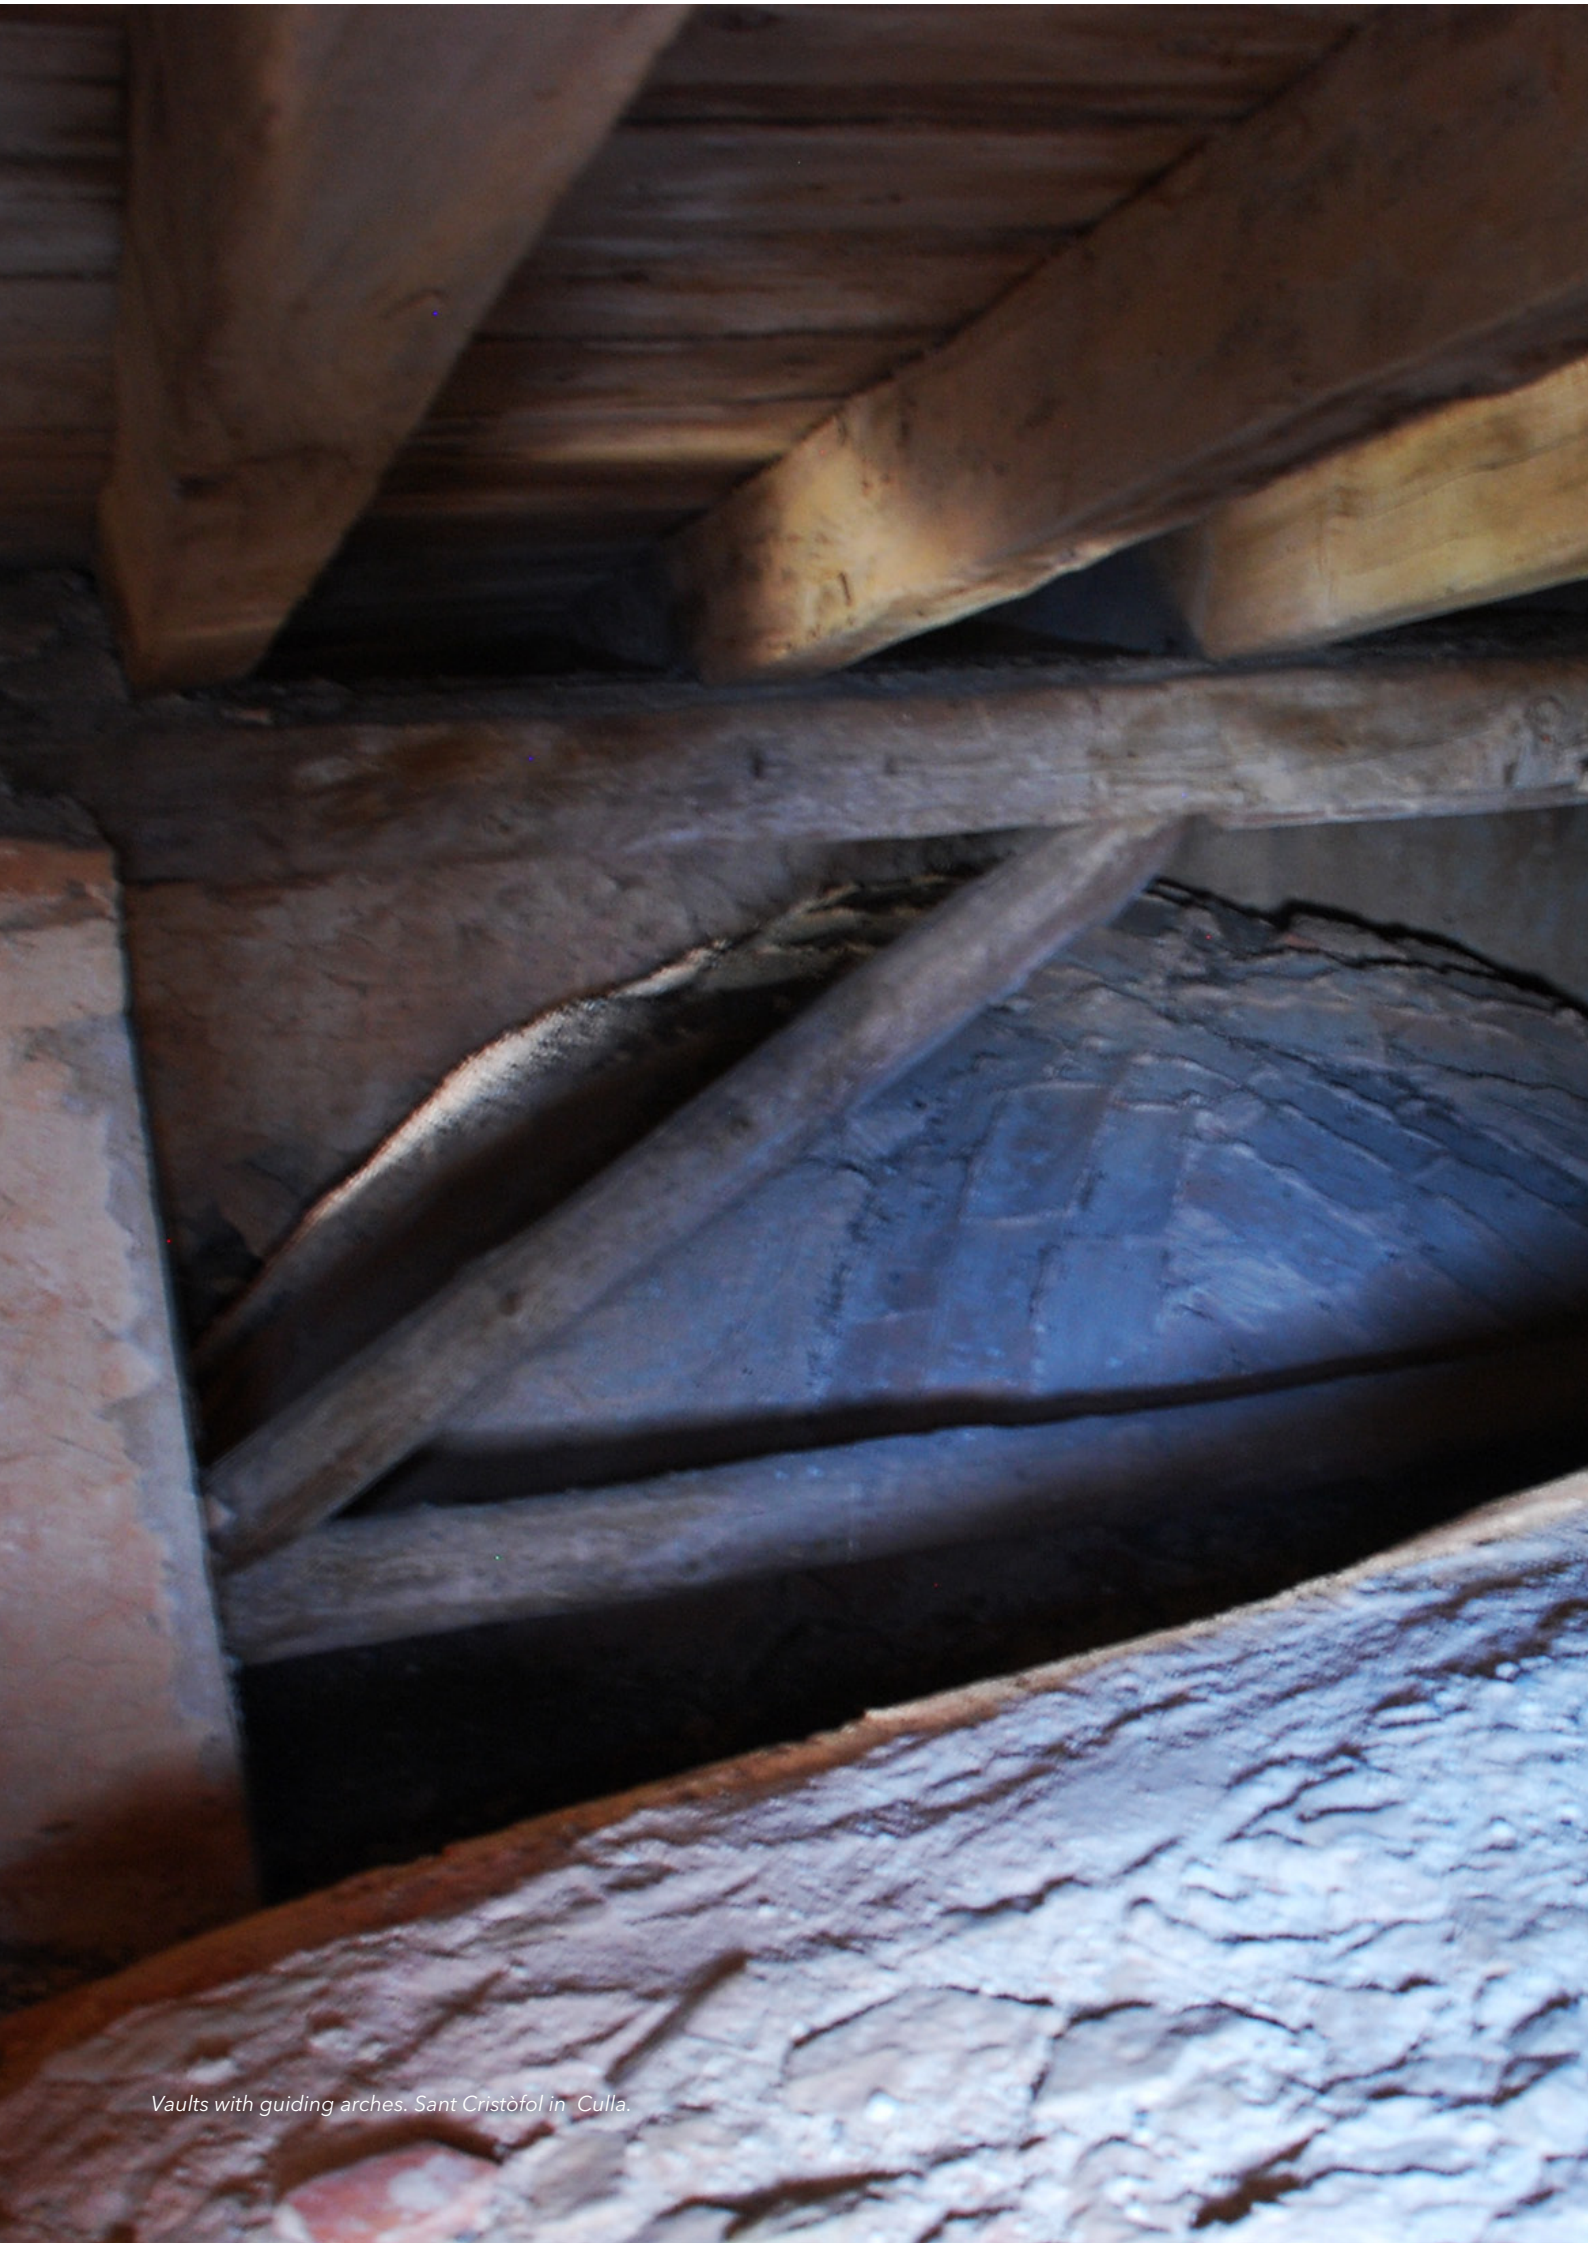
*Vaults with guiding arches. Sant Cristòfol in Culla.*

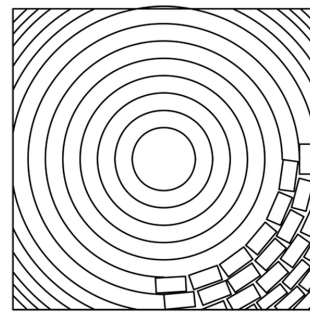
Figure 4.

Sail vaults were bricked starting from the vertex of the spaces that delimited them and following concentric rowlocks until reaching the crown.

*Brick disposition on sail vaults: choir of Ribesalbes, organ room of Suera and dome of Vilar de Canes*

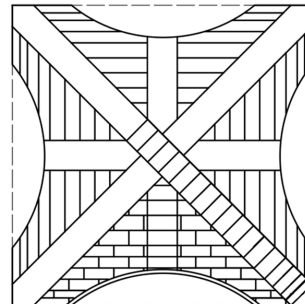
Figure 6.

It was the most sophisticated type of vault bricking, reminiscent of the Gothic vaulting, and based on the execution of the main nerves or ribs and the subsequent filling of the timbrel.

It consisted on the use of guiding arches that ran diagonally, as well as from the middle of the faces to the opposite ones, with rowlocks of bricks arranged parallel to their perimeters. Their construction started by bricking such guiding arches with a row of solid bricks joined by their stretcher faces, the diagonal arches first, and then those perpendicular to their perimeters. These last ones were bricked as from the crown of the discharging arches, which were made of solid bricks with stretcher bond. Then, the

*Brick disposition on groined vaults with guiding arches and rowlocks parallel to their perimeter: roof of the Communion chapel of Vila-real*

proper vault bricking started from the corners, over the guiding arches, allowing the latter to protrude on the underside. This type of vaults featured different panels joint by groins, the depth of which depended on the discharge arches.

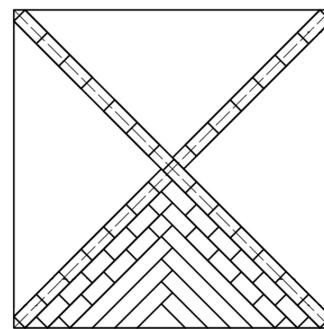
Figure 7.

The construction of this type of vaults began by bricking the guiding arches with solid bricks bound on their header face and arranged according to the diagonals of the surfaces to be covered. The vault was then completed by contiguous rowlocks of bricks arranged parallel to the guiding arches.

*Brick disposition on groined vaults with guiding arches and brick rowlocks parallel to them: vaults on the lateral naves of Culla*

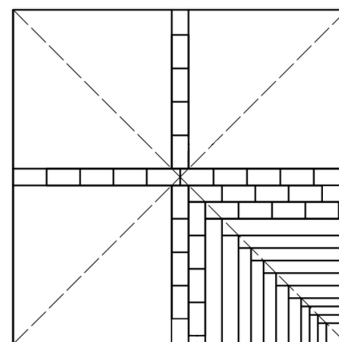
Figure 8.

*Brick disposition on groined vaults with guiding arches and brick rowlocks perpendicular to the perimeter: lateral naves of Culla*

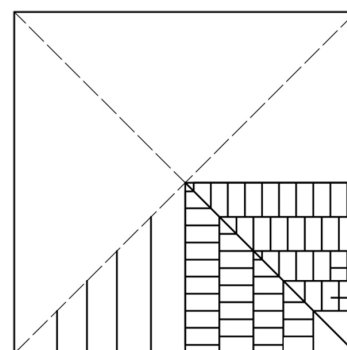
Figure 9.

*Brick disposition on groined vaults with header work bricks: organ hall of Castell de Cabres*

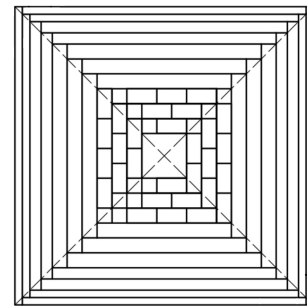
Figure 10.

This type of vaults were bricked with correlative rowlocks parallel to their perimeter.

The first rows to be bricked were those located next to the perimeter, then placing the following ones by means of hollow bricks perforated on their header

*Brick disposition on groined vaults with correlative rowlocks of bricks parallel to their perimeter: reconstructed vaults of the lateral naves of Vilar de Canes*

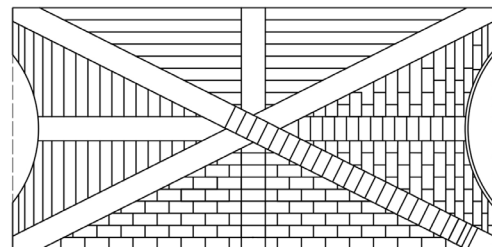
Figure 11.

*Brick disposition on barrel vaults with guiding arches: Vila-real's roof*

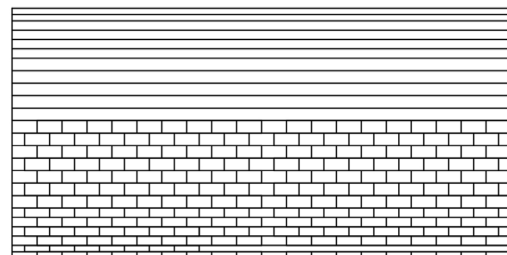
Figure 12.

*Brick disposition on barrel vaults with horizontal rowlocks: apse of Benifairó de les Valls*

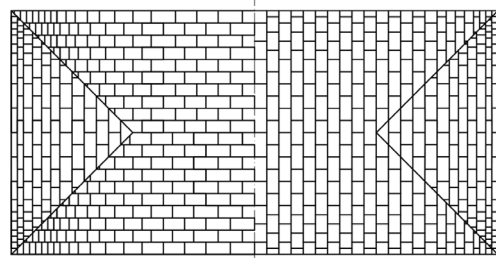
Figure 13.

The construction of these vaults started by bricking their perimeter and continued with rowlocks of bricks parallel to them, with the additional complexity of having to take into account the double curvature corresponding to the two cylinders that intersected (the one of the nave vault and the one of the lunettes). Probably influenced by the Treaty of Choisy (1883): figure 119.

*Brick disposition on barrel vaults with lunettes: Rebuilt vaults of the central nave in Vilar de Canes*
